On Guard Home Inspections Residential Property Inspection Report

Property address: **309 W. Main Street
Benson, NC 27504**

Inspection date: **2/19/2010**

Report number: 20100219NC030

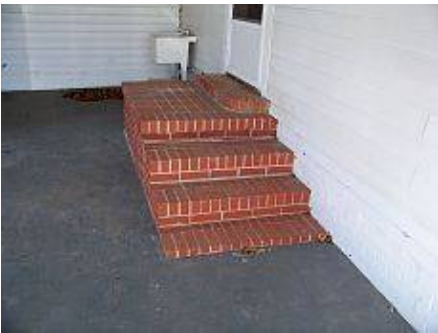
Photo 36

- 2) 🛠️ The carport steps have more than three risers with no handrail installed. This is a safety hazard. A qualified contractor should install graspable handrails that your hand can completely encircle at stairs where missing, and as per standard building practices.

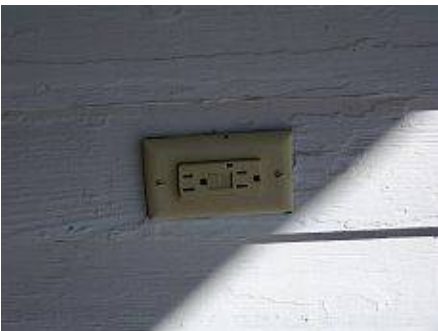
Photo 35

- 3) 🛠️ Exterior electric receptacles aren't waterproof or rated for use in wet areas. This is a safety hazard due to the risk of shock and fire. Repairs should be made as necessary, and by a qualified electrician if necessary, so all exterior receptacles are waterproof as per standard building practices.

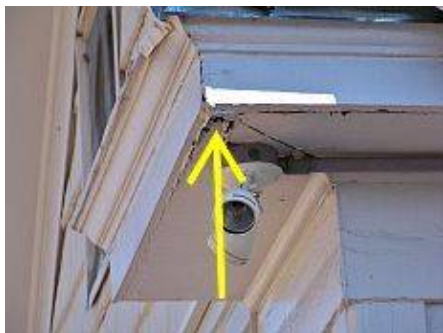
Photo 39

Soffit boards are deteriorated in one or more areas. A qualified contractor should evaluate and make repairs as necessary.

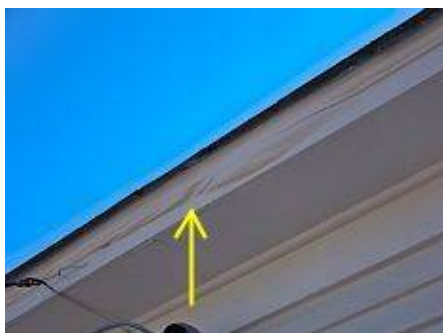
Photo 38

Fascia boards are deteriorated in one or more areas. A qualified contractor should evaluate and make repairs as necessary.

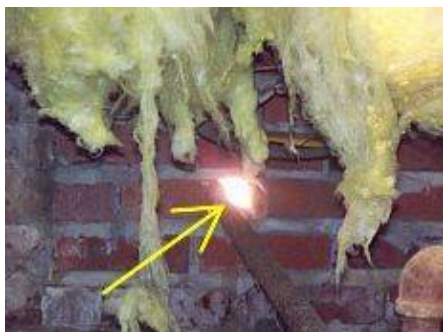
Photo 29

Gaps exist at openings around the exterior, such as those where outside faucets, refrigerant lines, and/or gas supply pipes penetrate the exterior. Gaps should be sealed as necessary to prevent moisture intrusion and entry by vermin.

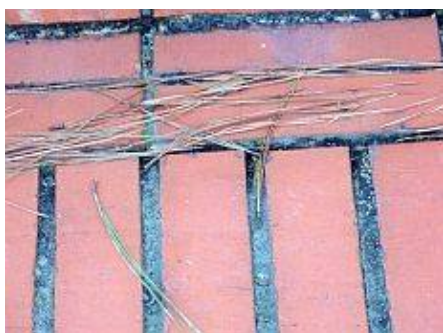
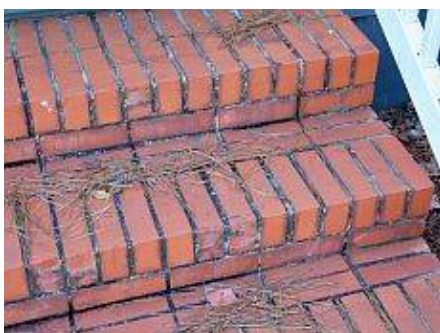
Minor cracks were found in the brick steps. A qualified contractor should evaluate and make repairs as necessary, such as repointing mortar to prevent water intrusion and further deterioration in the future.

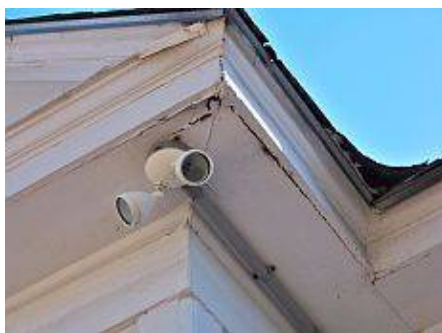
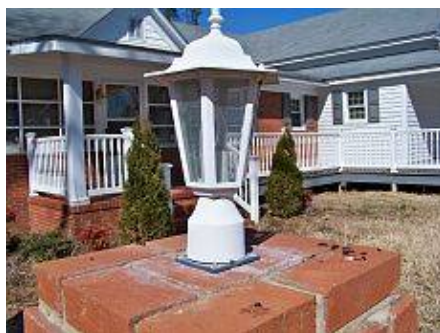
Several exterior light fixtures have missing bulbs or bulbs that did not light when tested and could not be fully evaluated. Bulbs may simply need to be replaced or installed, or repairs or replacement of the light fixtures may be necessary.

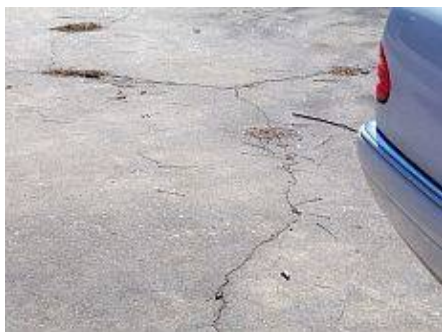
Photo 34

Minor cracks were found in the driveway. However they don't appear to be a structural concern and no trip hazards were found. No immediate action is recommended, but the client(s) may wish to have repairs made or have cracked sections replaced for aesthetic reasons.

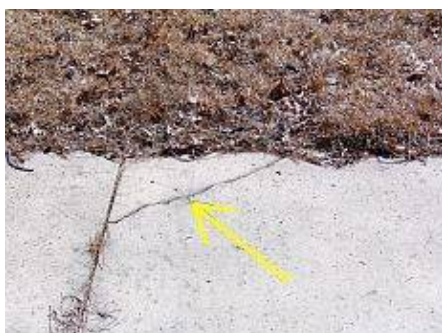
Photo 45

Minor cracks were found in the sidewalk. However they don't appear to be a structural concern and no trip hazards were found. No immediate action is recommended, but the client(s) may wish to have repairs made or have cracked sections replaced for aesthetic reasons.

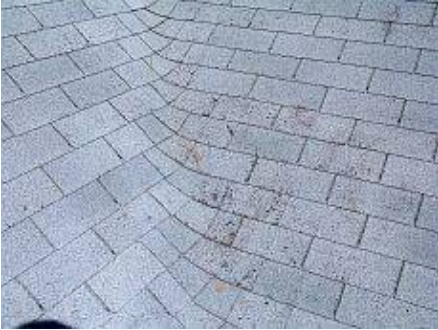
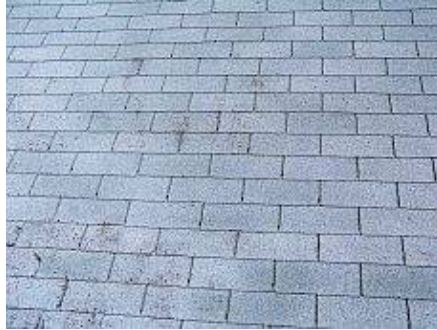
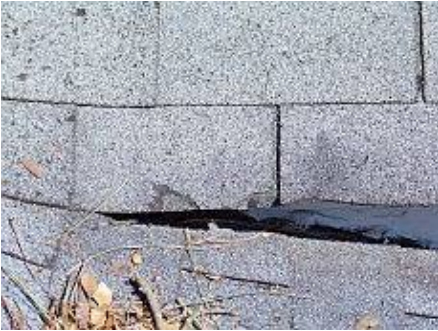
The roof surface material is near the end of its service life and needs replacing soon. The composition shingles are deteriorated and leaks may occur as a result. The client(s) should consult with a qualified roofing contractor to determine replacement options and costs.

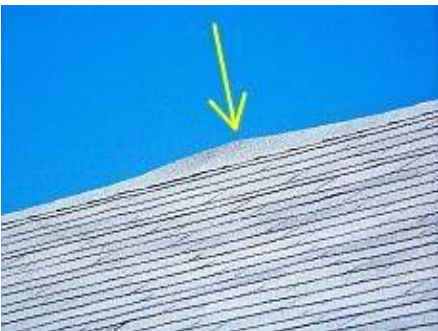
Photo 46

Several composition shingles have raised, most likely due to nails that have loosened. Leaks may occur as a result. A qualified roofing contractor should evaluate and make repairs as necessary, such as reseating nails.

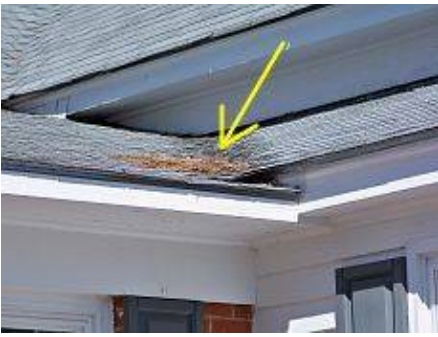
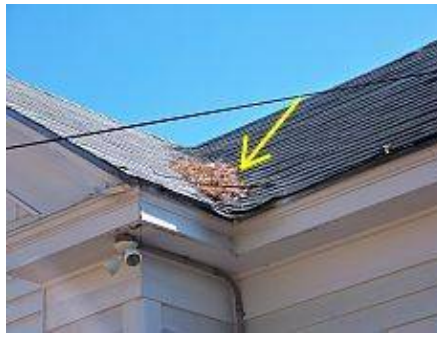
Debris such as leaves, needles, seeds, etc. have accumulated on the roof. This is a conducive condition for wood destroying insects and organisms since water may not flow easily off the roof, and may enter gaps in the roof surface. Leaks may occur as a result. Debris should be cleaned from the roof now and as necessary in the future.

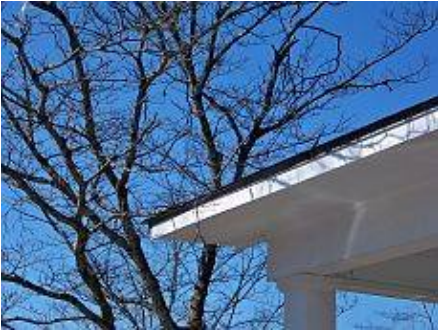
Photo 33

-
- 17) 🗑️ Trees are in contact with or are close to the roof edge(s) in one or more areas. Damage to the roof may result, especially during high winds. Vegetation can also act as a conduit for wood destroying insects. Vegetation should be pruned back and/or removed as necessary to prevent damage and infestation by wood destroying insects.

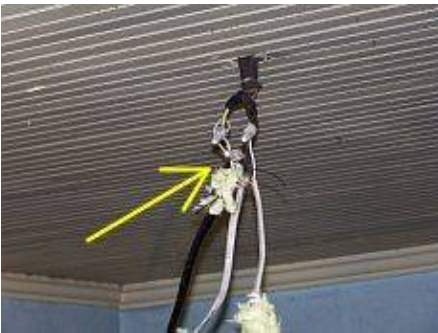
Photo 50

-
- 19) 🔧⚡ Wire splices are exposed due to not being contained in a covered junction box. This is a safety hazard due to the risk of shock and fire. A qualified electrician should evaluate and make repairs as necessary. For example, install securely mounted junction boxes with cover plates where needed to contain wiring splices.

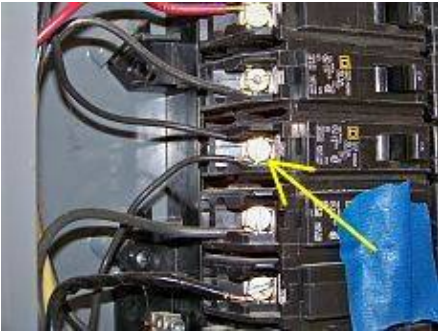
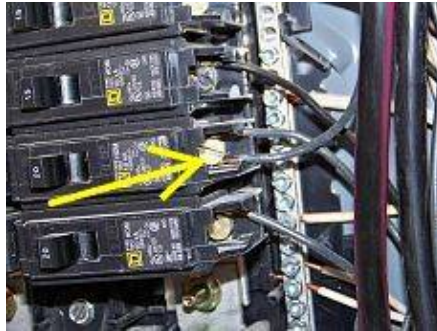
One or more overcurrent protection devices (circuit breakers) are "double tapped", where 2 or more wires are clamped in a terminal designed for only one wire. This is a safety hazard since the bolt or screw may tighten securely against one wire, but leave others loose. Arcing, sparks and fires may result. A qualified electrician should evaluate and repair as necessary.

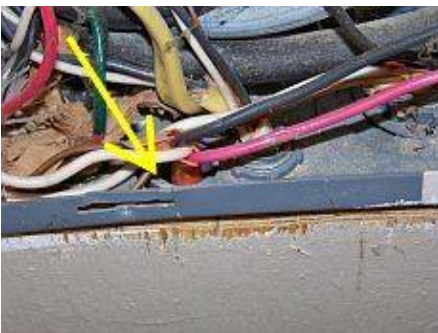
Photo 52
Main Service Panel

One or more bushings are missing from where wires enter holes in the main service panel. This is a safety hazard since the wiring insulation can be cut or abraded on the metal edge of the hole(s). A qualified electrician should install bushings where missing.

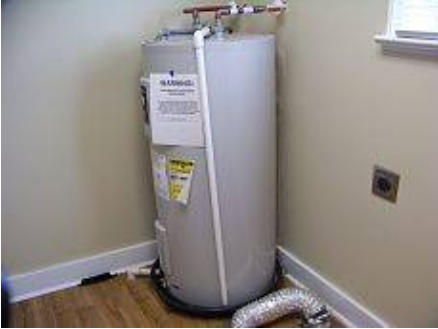
Photo 19

- 24) ⓘ The water heater was turned off at the time of the inspection. The inspector was unable to fully evaluate the water heater.

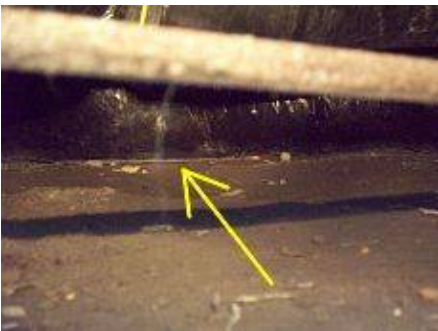
Photo 30

- 26) 🔧🔍 Heating/cooling ducts are lying on the ground. Ducts should be supported (typically with straps or hangers) so that they are not in contact with the ground and subject to damage from moisture. A qualified contractor should evaluate and make repairs as necessary so ducts are suspended as per standard building practices, and not in contact with the ground.

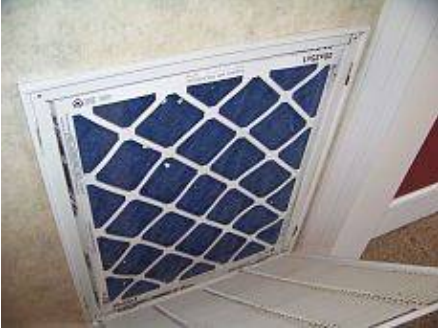
Photo 23

Air handler filter should be checked monthly in the future and replaced as necessary.

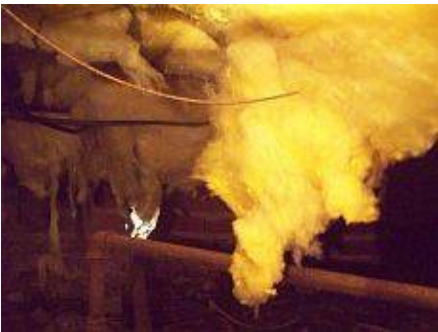
Photo 28

Insulation under the floor in the crawlspace is deteriorated and has fallen down. A qualified contractor should make repairs as necessary to restore the insulation to its original rating.

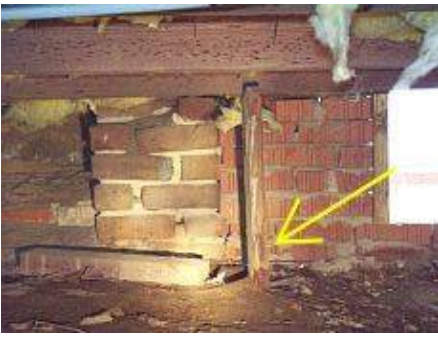
Photo 31

Soil is in contact with one or more wooden support post bases. Soil should be graded or removed to maintain a six inch gap between the support post bases and the soil below.

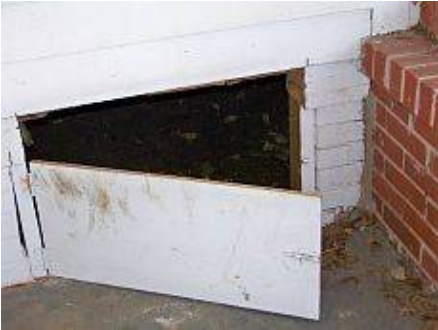
Photo 37

The crawl space access door is too small for the opening. This may allow animals such as vermin or pets may enter the crawl space and nest, die and/or leave feces and urine. A qualified contractor should install the correct size door.

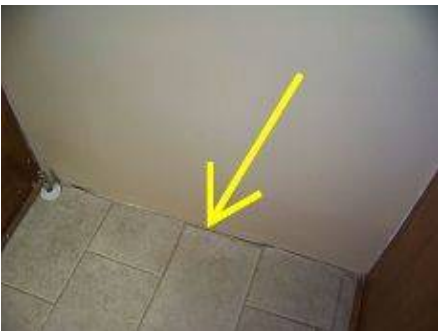
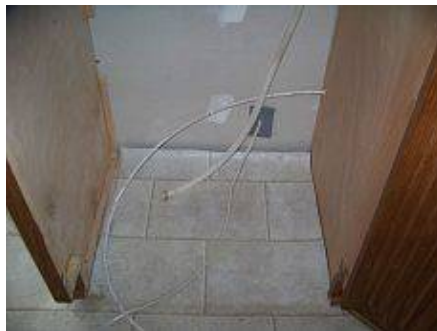
Vinyl flooring in one or more "wet" areas is loose. The wooden subfloor below may be damaged by water intrusion. A qualified contractor should evaluate and replace or repair the flooring.

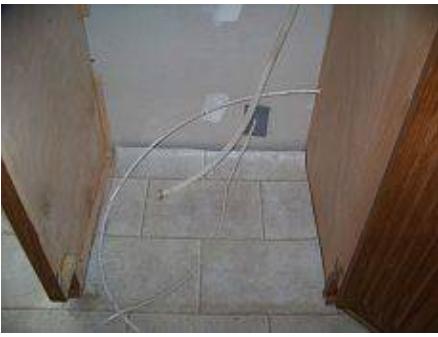
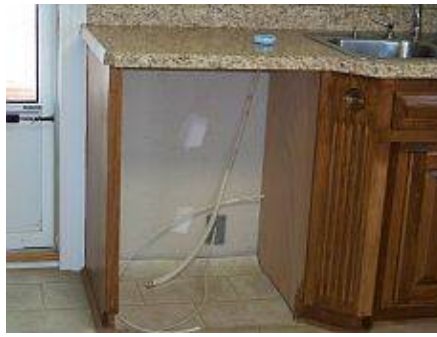
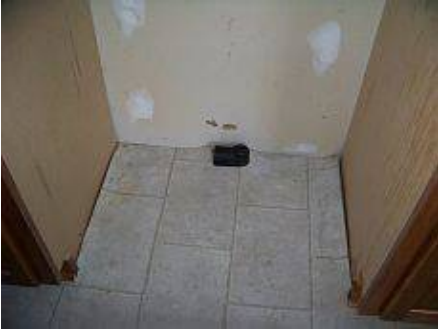
The refrigerator, dishwasher and range were NOT installed at the time of inspection.

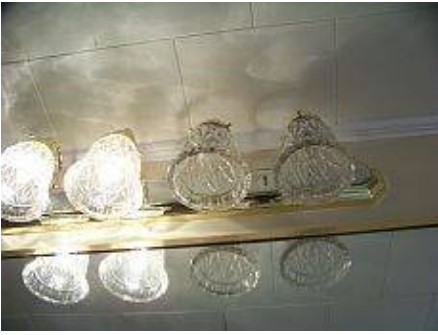
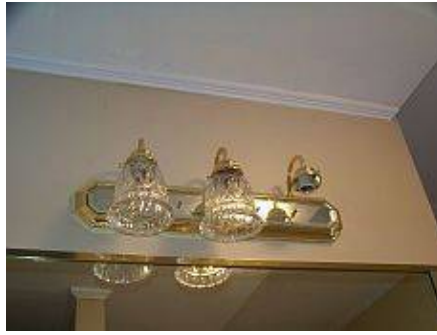
Bathroom light fixtures have missing bulbs and could not be fully evaluated. Bulbs may simply need to be

installed, or repairs or replacement may be necessary.

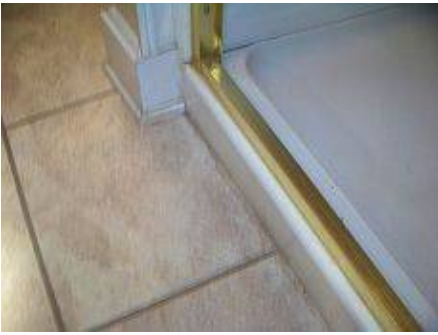
Photo 20

Caulk is missing or deteriorated along the base of one or more showers, where flooring meets the shower. It should be replaced where deteriorated and/or applied where missing to prevent water intrusion and damage to the floor structure.

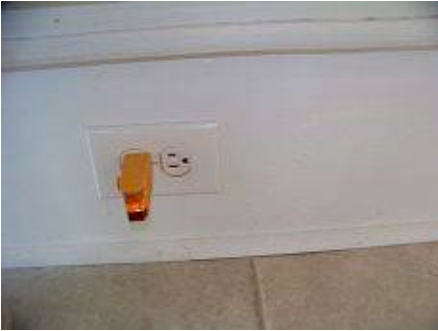
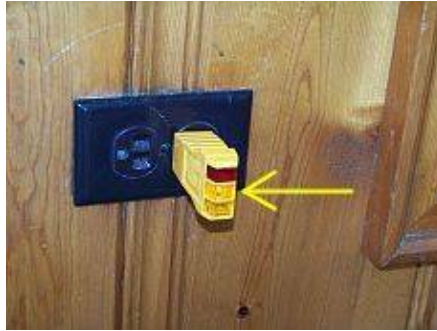
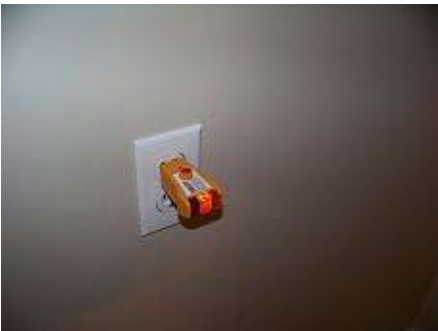
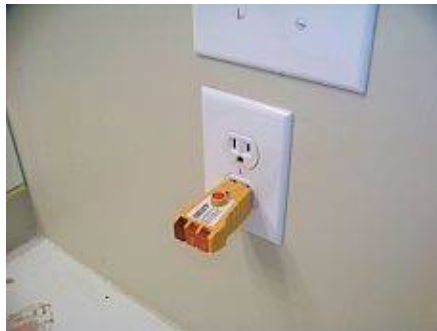
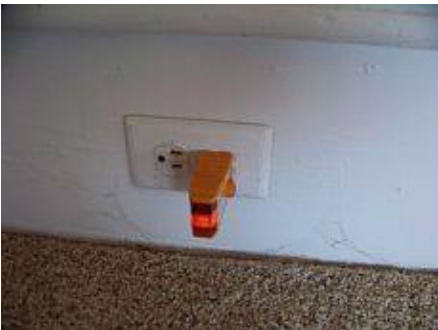
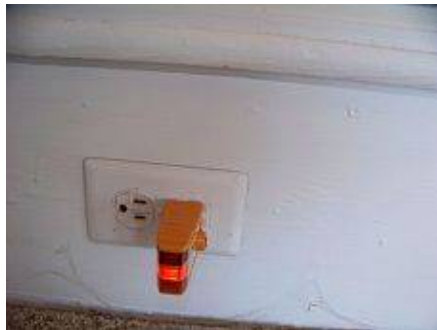
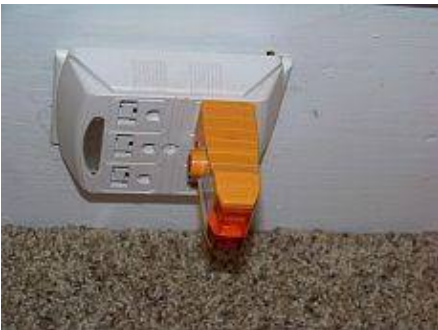
Several open ground, three-pronged electric receptacles were found throughout the house. This is a safety hazard due to the risk of shock. A qualified electrician should evaluate and make repairs as necessary. For example, replacing receptacles or correcting wiring circuits.

Grounding type receptacles began being required in residential structures during the 1960s. Based on the age of this structure and the presence of 2-pronged receptacles in some areas of this structure, an acceptable repair may be to simply replace the ungrounded 3-pronged receptacles with 2-pronged receptacles. However the following appliances require grounding type receptacles:

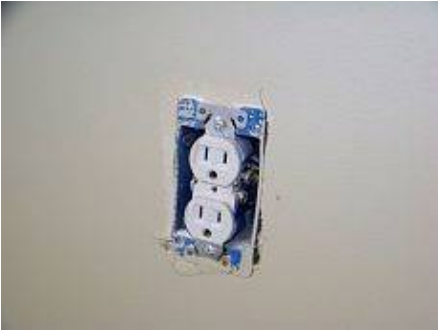
Photo 12

Cover plate is missing from electric boxes, such as for receptacles, switches and/or junction boxes. They

are intended to contain fire and prevent electric shock from exposed wires. This is a safety hazard due to the risk of fire and shock. Cover plates should be installed where missing.

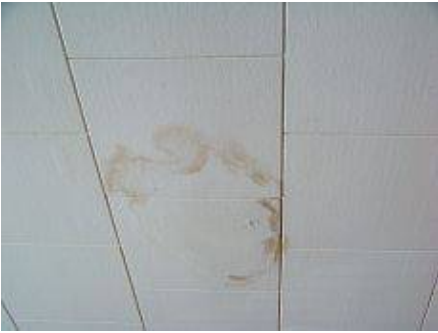
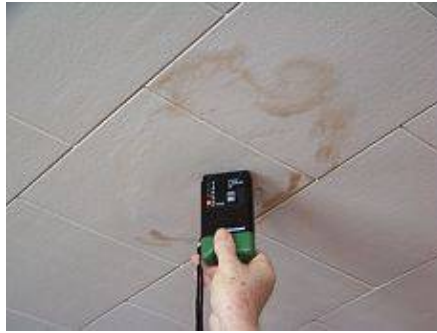
Stains with elevated levels of moisture were found in one or more ceiling areas. The stain appear to be due to roof leaks however the origin of the leak could not be found. A qualified roofing contractor should evaluate and repair as necessary.

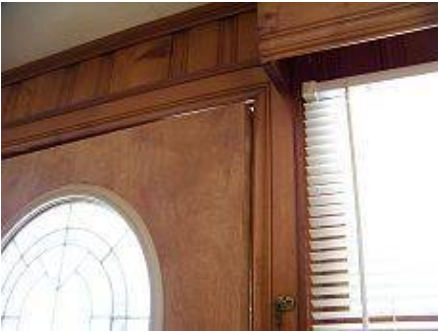
Photo 16

The front door binds in its jamb and is difficult to open and close. A qualified contractor should evaluate and repair as necessary. For example, adjusting jambs or trimming doors.

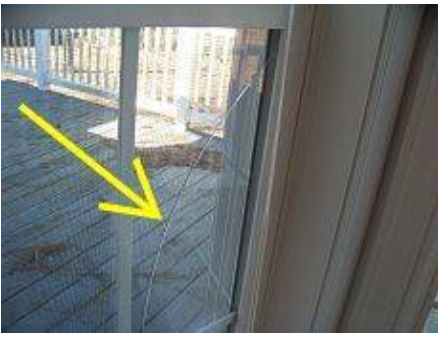
Photo 9

Glass in the dining room bay window is broken. A qualified contractor should replace glass where necessary.

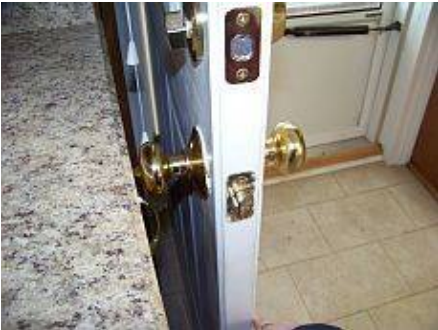
Photo 7

The carport entry door handle strikes the countertop when opened. Fixtures such as door stops are missing in one or more areas. Recommend having a qualified contractor install fixtures where missing.

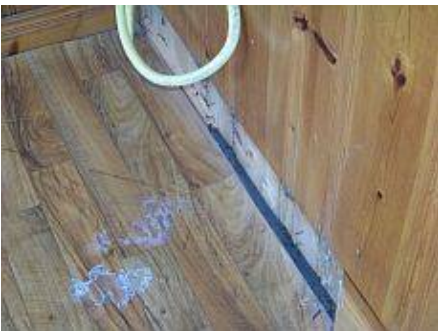
Photo 15

Trim is missing in the family room in one or more areas. Recommend having a qualified contractor install trim where missing.
